## UCAMA Construction Report #8

Because of the number of inquiries we have received regarding the progress of our new museum facility on Jasper Avenue, UCAMA has decided to prepare month end construction reports. These reports will be sent out to our friends and supporters until Phase 1 is complete.

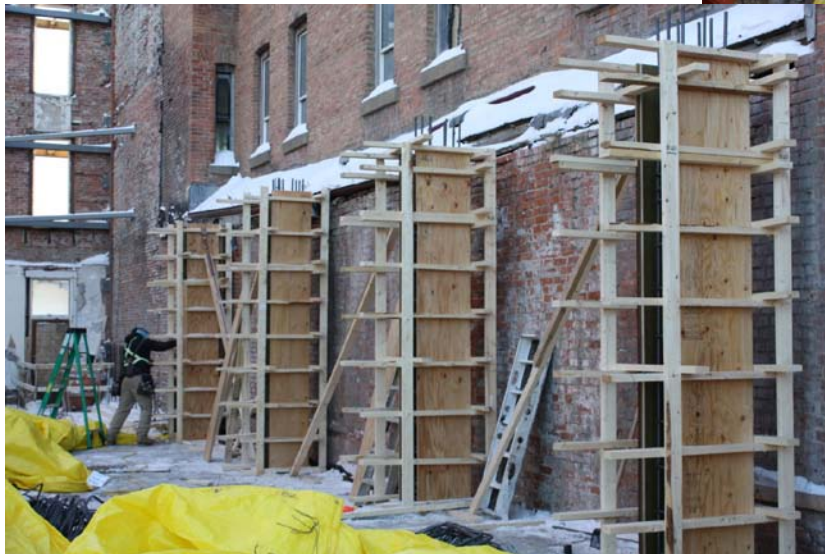
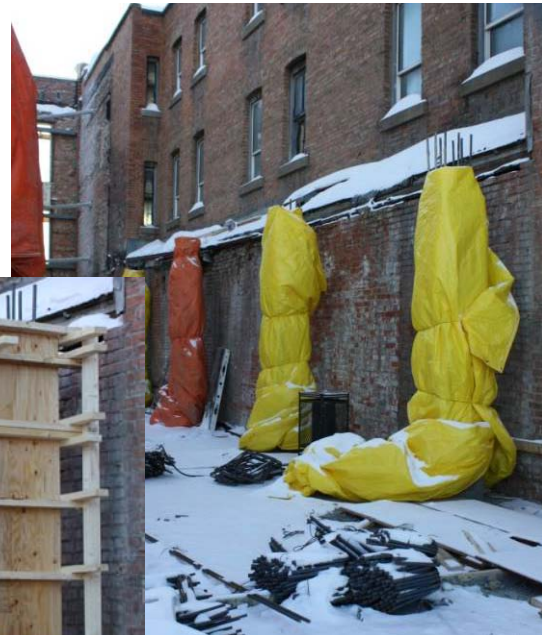
The columns on the west wall of the Lodge have been framed in and the concrete poured. They are covered with tarps to allow enough heat to build up to properly cure the columns. Interestingly the rebar in the columns retains heat from the poured concrete assisting in the curing process. The columns in the middle of the building have also been poured and covered with tarps.
